HARTZELL PROPELLER INC.

Aircraft Accident/Incident Report No.: 130809

NTSB File No.: ERA13FA358

Aircraft: Rockwell International 690B

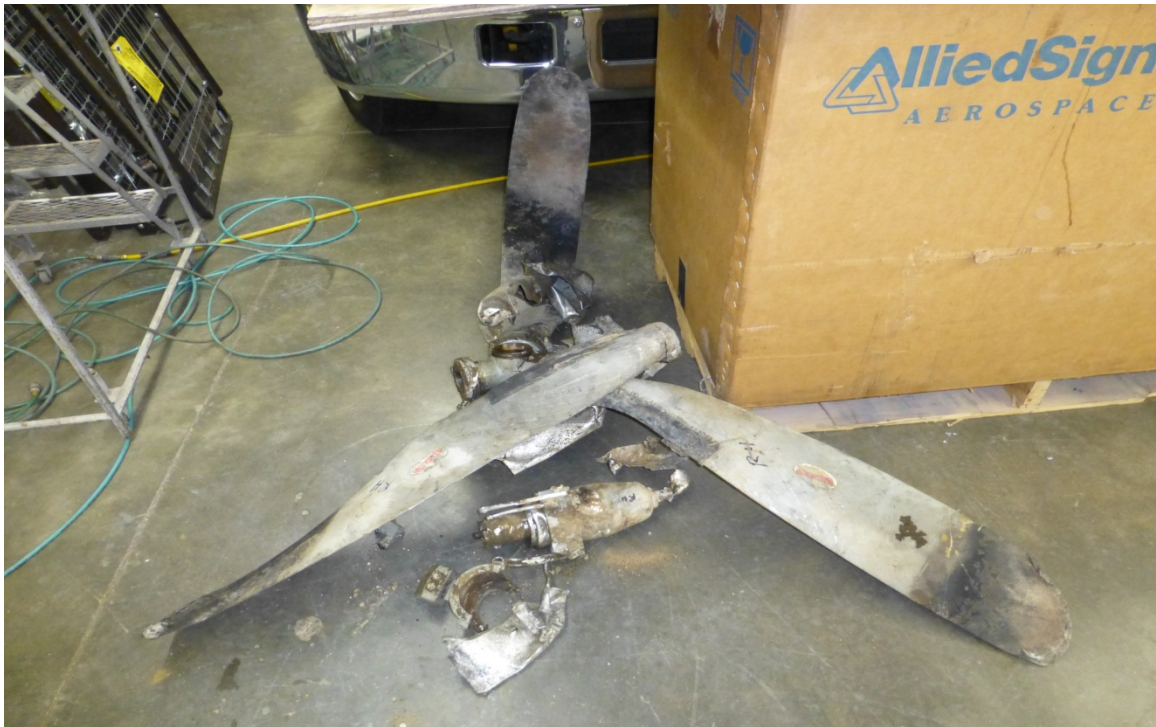
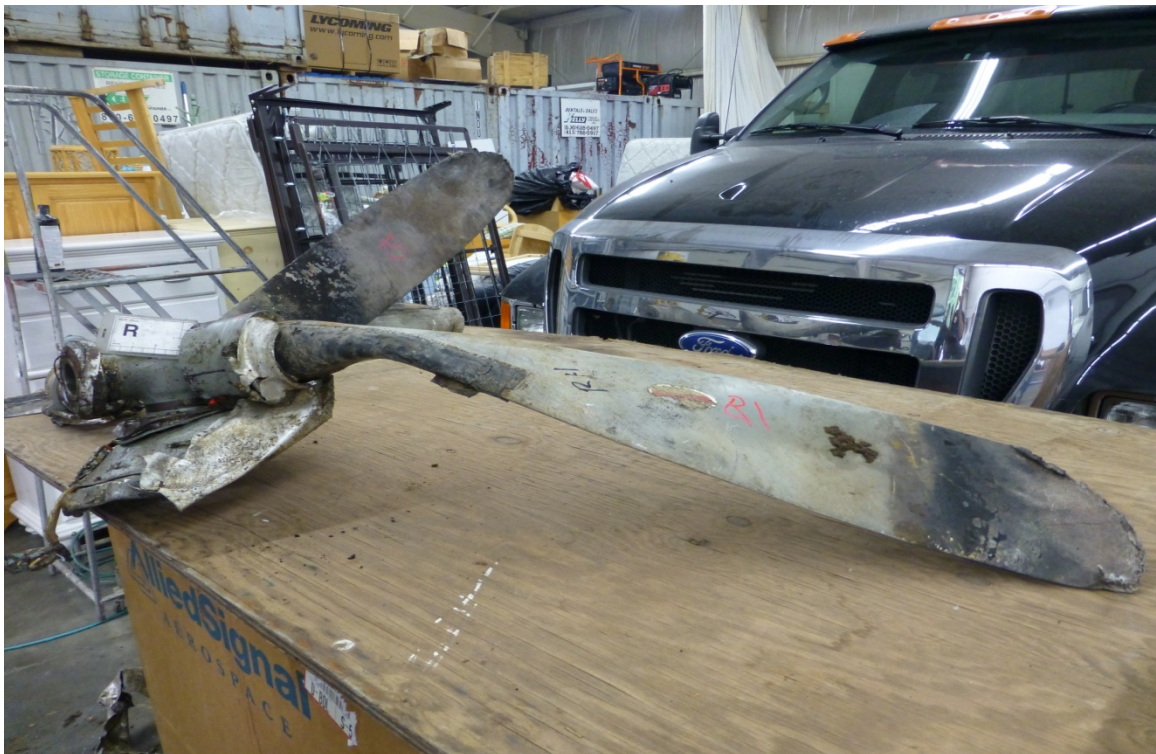
The propeller was thermally damaged. The spinner dome was partially missing and only fragmented pieces remained. The blade tips were melted. The cylinder and piston were fractured off the hub. The R3 blade was fractured off the hub and the lower half of the R3 clamp was missing.

Photo #1, Right propeller as received.

Photo #2, right propeller as received.

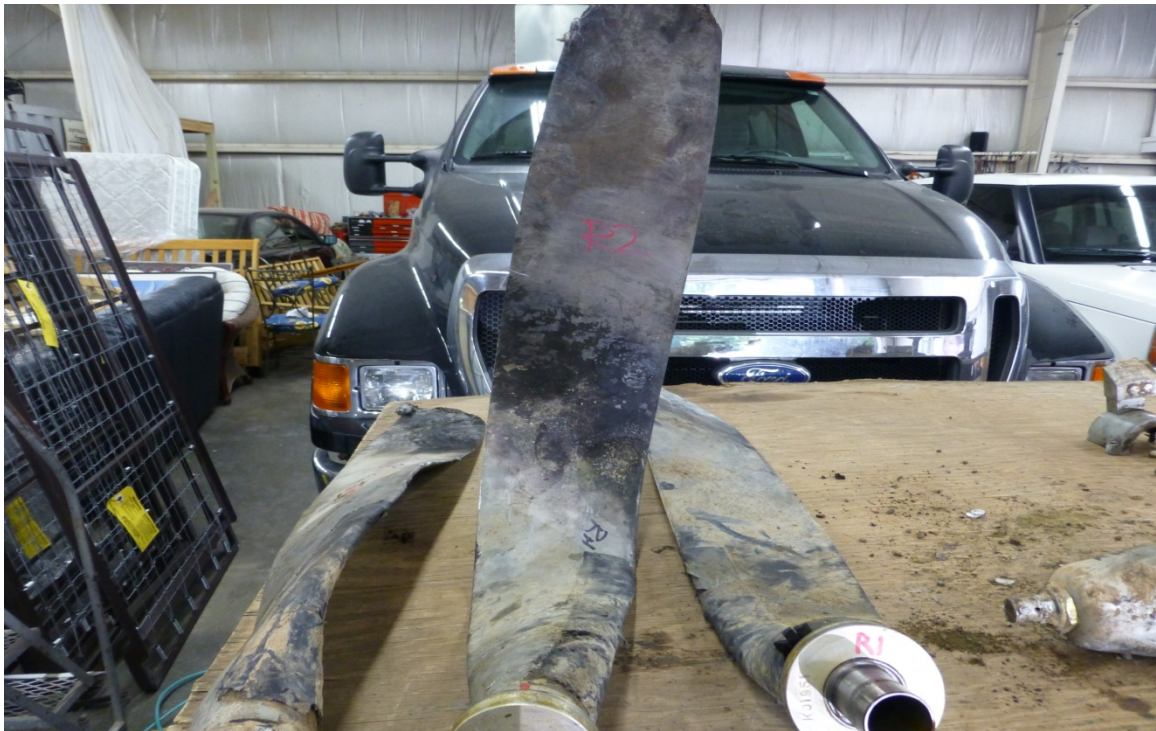
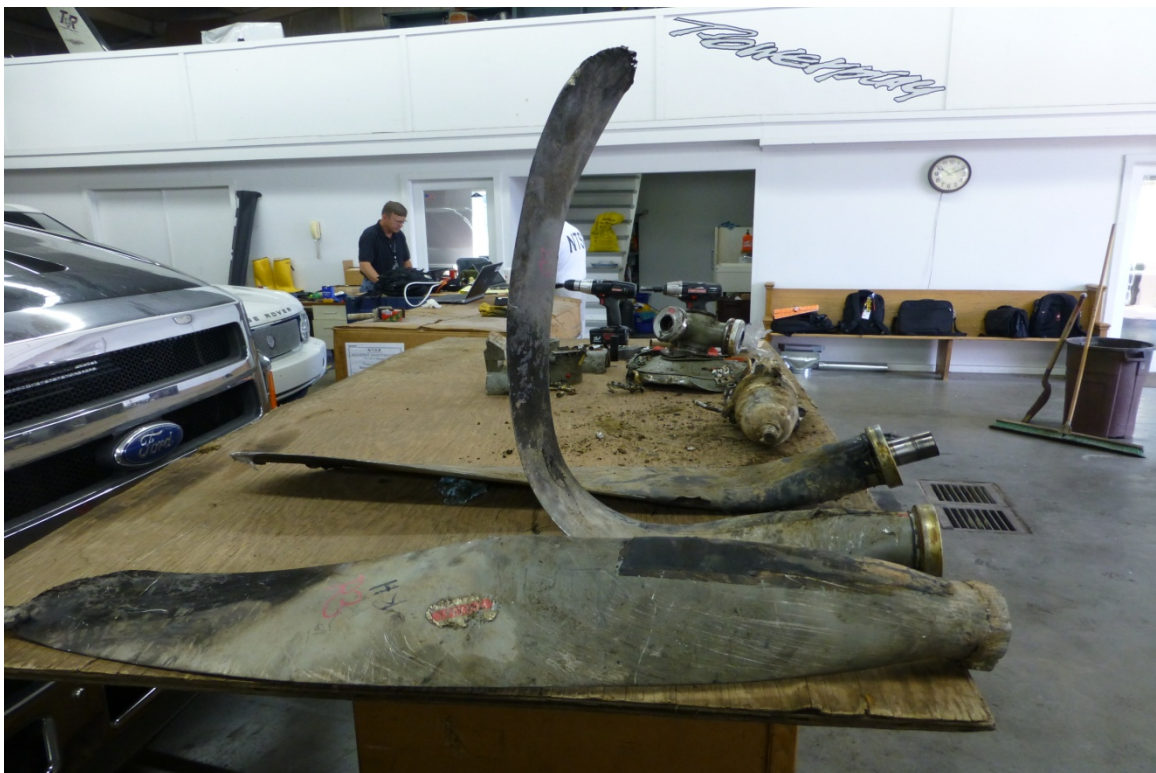
paint, camber side	-	missing, thermally damaged.
paint, flat side	-	missing, thermally damaged.
bend	-	slight bend aft.
twist	-	none.
lead edge damage	-	scrapes, tip missing due to thermal damage.
trail edge damage	-	scrapes, tip missing due to thermal damage.
butt impression	-	small impression from hub.

paint, camber side	-	missing, thermally damaged.
paint, flat side	-	missing, thermally damaged.
bend	-	90° bend forward at midblade.
twist	-	none.
lead edge damage	-	scrapes, tip missing due to thermal damage.
trail edge damage	-	scrapes, tip missing due to thermal damage.
butt impression	-	none.

paint, camber side	-	missing, thermally damaged.
paint, flat side	-	missing, thermally damaged.
bend	-	slight bend aft at midblade.
twist	-	slight twist at midblade forward.
lead edge damage	-	scrapes, tip missing due to thermal damage.
trail edge damage	-	scrapes, tip missing due to thermal damage.
butt impression	-	small impression from hub.

Photo #3, Right propeller blades

Photo #4, Right propeller blades.

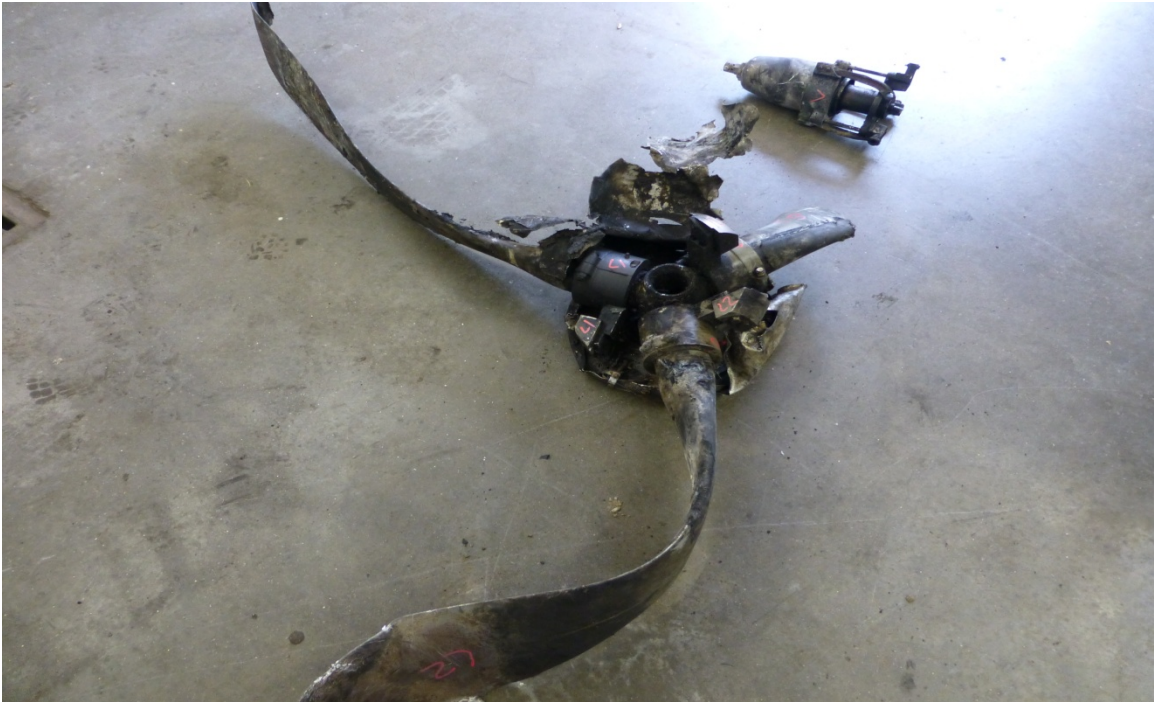
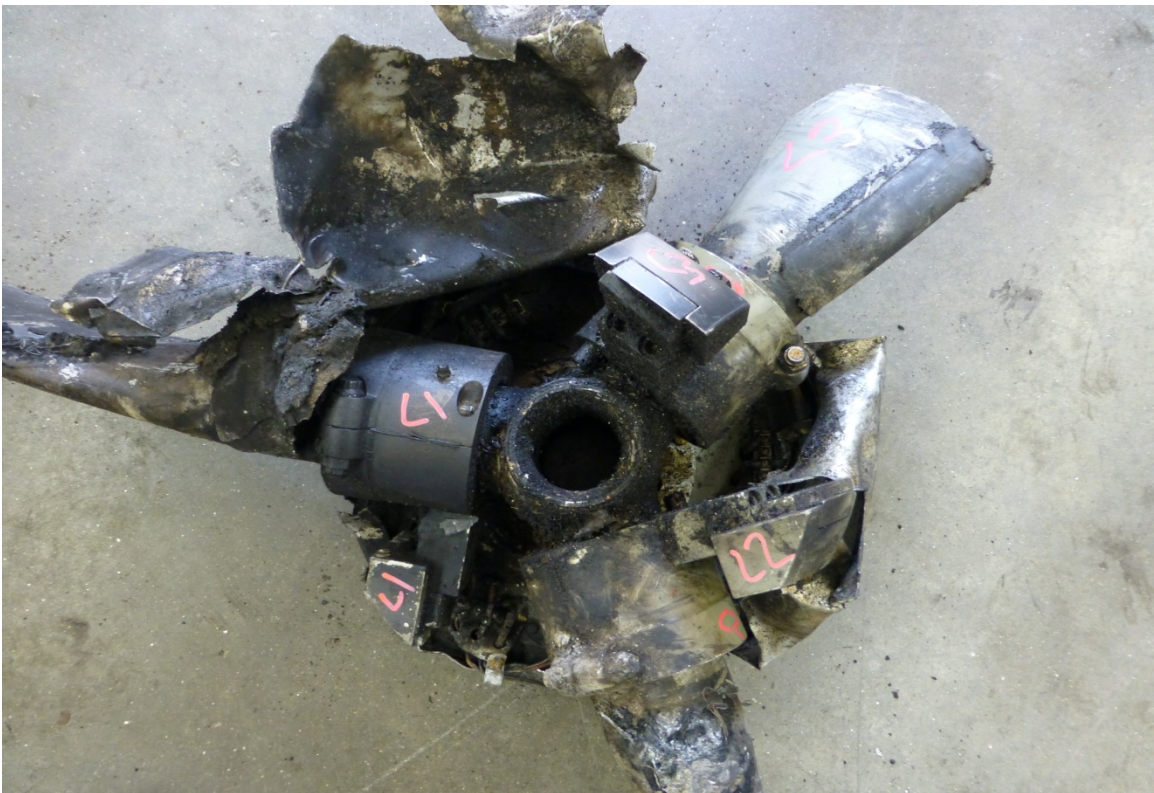
The propeller had severe thermal damage. The spinner dome fragmented and only small pieces remained. The cylinder and piston were fractured off the hub. The L3 blade was fractured about 12” from the blade butt.

Photo #5, Left propeller as received.

Photo #6, Left propeller as received.

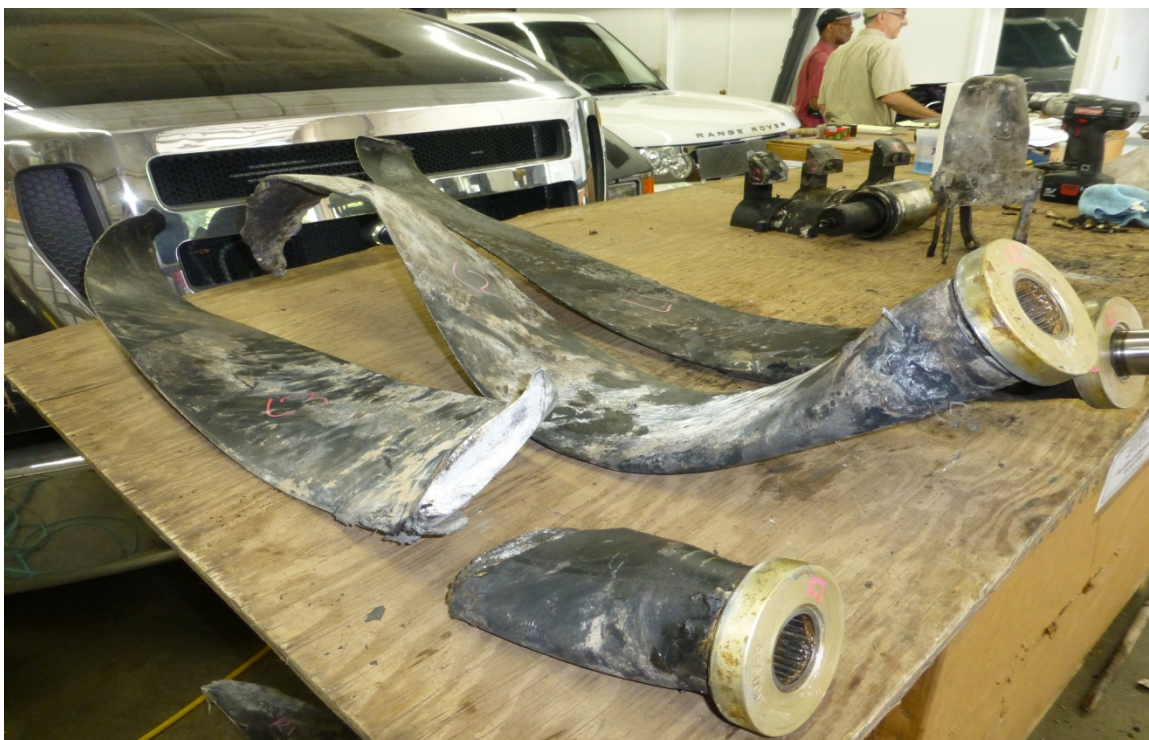
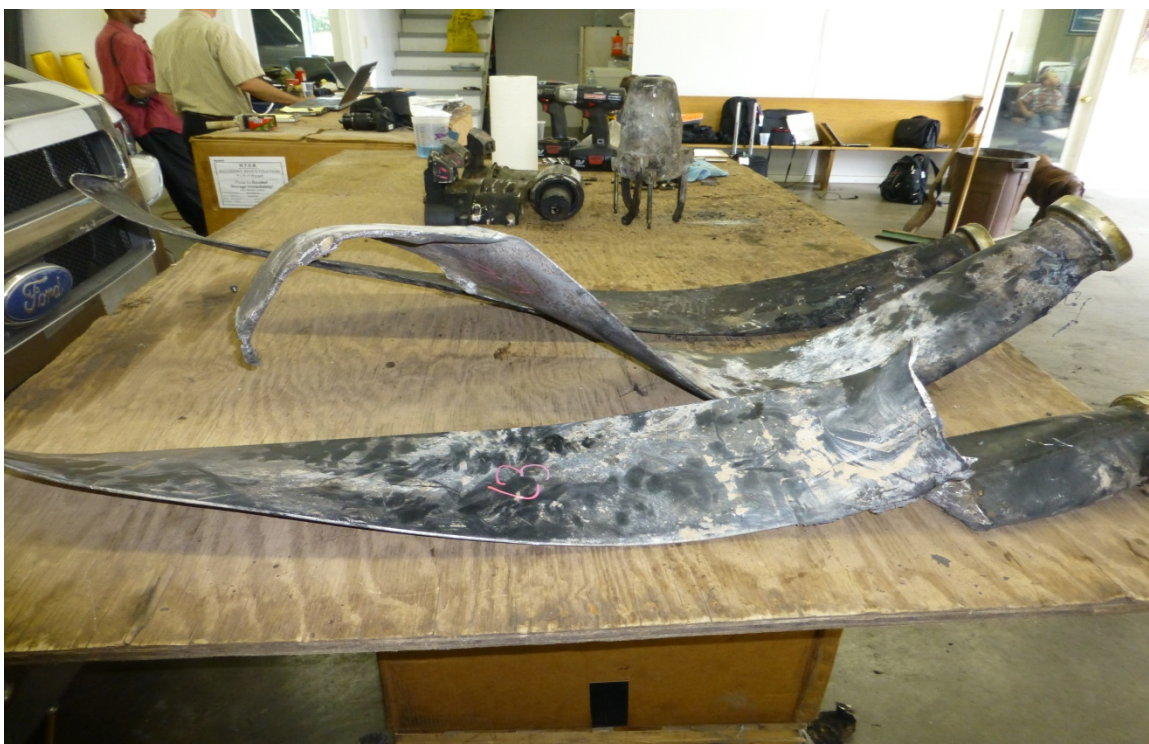
paint, camber side	-	missing, thermally damaged.
paint, flat side	-	missing, thermally damaged.
bend	-	bent aft, tip curled under.
twist	-	none.
lead edge damage	-	bends and scrapes.
trail edge damage	-	scrapes.
butt impression	-	hub mark on trailing edge.

paint, camber side	-	missing, thermally damaged.
paint, flat side	-	missing, thermally damaged.
bend	-	bent aft 60° midblade, forward at tip.
twist	-	slight twist forward and aft.
lead edge damage	-	Last ¼ of blade missing, thermally damaged.
trail edge damage	-	gouges and some tears.
butt impression	-	hub mark on trailing edge.

paint, camber side	-	missing, thermally damaged.
paint, flat side	-	missing, thermally damaged.
bend	-	fractured 10" from blade butt.
twist	-	tip curled under.
lead edge damage	-	bends at tip.
trail edge damage	-	bends at tip.
butt impression	-	hub mark on trailing edge.

Photo #7, Left propeller blades

Photo #8, Left propeller blades.
